ISS.A

## **SUBJECT : ERRONEOUS AIRSPEED/ALTITUDE INDICATIONS**

*Note : This FCOM Bulletin has been revised to also address the A340-500 and A340-600 aircraft.*

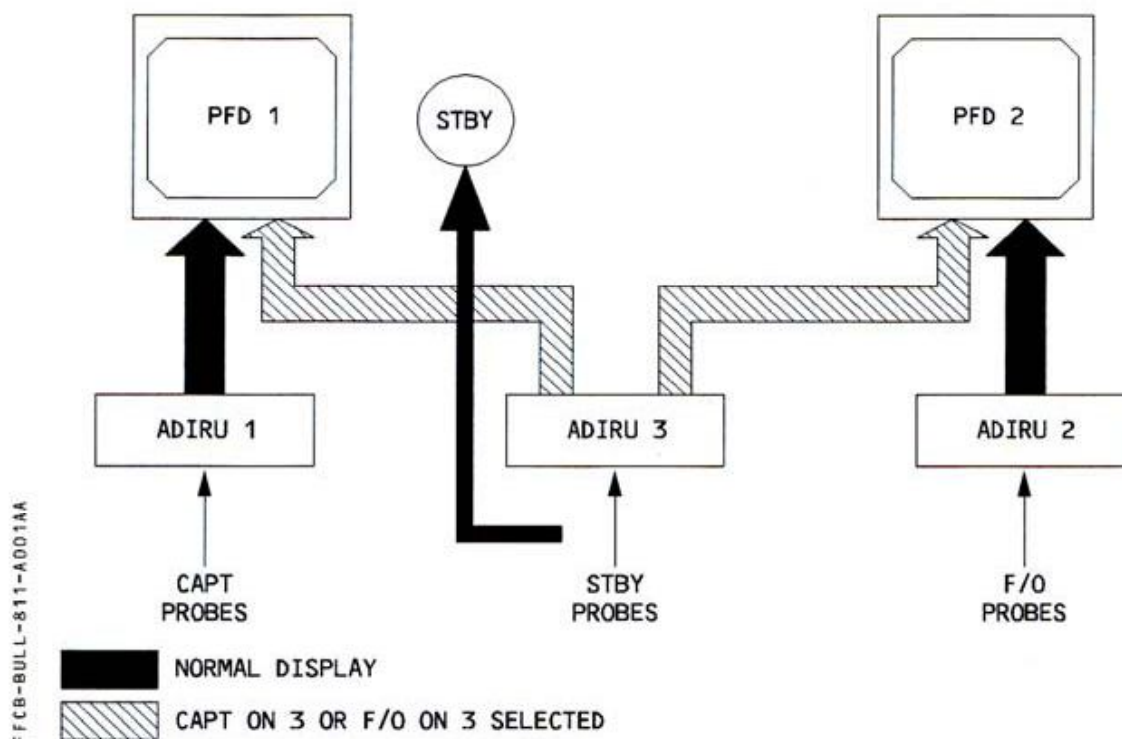
The CAPT pitot and static probes supply ADIRU 1, which is normally used for display on the CAPT's PFD.

The F/O pitot and static probes supply ADIRU 2, which is normally used for display on the F/O's PFD.

The STBY pitot and static probes supply ADIRU 3, which can be used for display on either PFD in case of failure. They also directly supply the standby instruments.
